KT south suwon branch UPS batteries (AGM 80-12)

Sample: Sebang Rocket ES 80-12 AGM(12V 80Ah:Korean Products) 8pcs(2set Serial connection, 1set is 4pcs)+3pcs

Regeneration Report for UPS Battery(AGM) in Korea

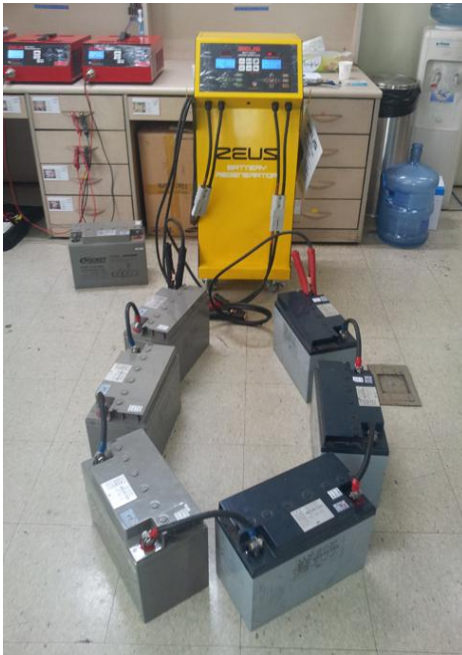
Process : 1. Repowertek visited KT south suwon branch on Aug 24th 2011 and chose 8pcs batteries as sample.

Repowertek charged with the KT style after checking voltage and internal resistance.

2. Checked RC after discharging all of the batteries on Aug 25th 2011. Restored 1se(4pcs) with ZEUS regenerator and charged another set(4pcs) with KT style.
